Problem Description:

SMT component U5 QFN 20-pin is having insufficient solder volume at reflow.

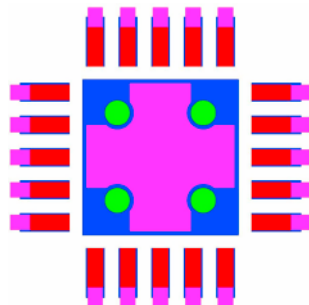
For leadless components, the terminal should cover 90%-100% of the SMT pad on the printed circuit board. On this assembly, the QFN covers 79% (terminal length is 0.0236" and SMT pad length is 0.0299") of the SMT pad. The root cause of the insufficient solder volume is a result of too much surface area for the solder to wet to with enough left over to form an acceptable solder joint.

On leadless components, solder will uniformly wet to the surfaces of the terminal and SMT pad. When the terminal is 90%-100% of the SMT pad, solder is shared between the two surfaces. When the SMT pad is longer than the terminal, it creates surface area that is not shared between the two surfaces. Solder will be pulled from the joint during reflow to cover the additional surface area and the result is insufficient solder volume at the terminal.

(blue = SMT pad, red = IC foot, magenta = recommended stencil aperture, green = drill)

To eliminate the insufficient solder problems with the QFN component, the volume of solder printed must be increased, given the small leadless terminals and large, comparatively, SMT pads. Fine Line Stencil has developed proven formulas that calculate the required volume increase eliminate the insufficient solder volume problem without causing bridging. The recommended stencil aperture size is as follows:

QFN 20-pin: 0.009" x 0.0355" (10.5% volume increase)

To minimize voids in the thermal pad, the four vias are not pasted. Applying solder paste around, but not directly over, the open vias minimizes the amount of flux and solder that gets lost to the via barrels. Voids in thermal pads with open vias are common not due to trapped gases, but insufficient solder volume. Not printing directly over the vias retains more of the solder volume for the joint between the PCB and component thermal pads.

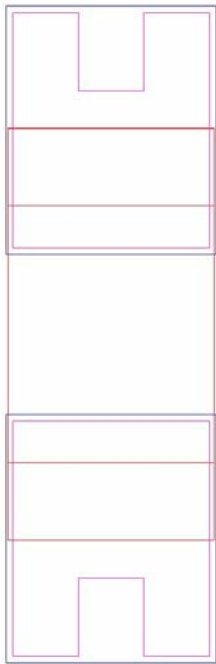
0603 and 0805 Chips

The 0603 and 0805 land pads are too far apart for the sizes of the chip packages. Any shift at pick-and-place can cause tombstone problems at reflow. To eliminate the tombstone potential, solder paste was removed from the back end of the chips. This will lower the wetting strength at the ends of the terminals and reduce the downward pull on the chip terminals. When one terminal has a much larger downward pull, due to more solder paste wetting to the terminal, the chip can be tipped onto its end causing it to tombstone.

(blue = SMT pad, red = chip package and terminals, magenta = recommended stencil aperture)
