## NC676 Solder Paste

Alloy: **63/37 Type 3** Metal Loading: **89.5%**  
QC/Lot#: **23826** Mfg Date: **7/18/2012**

Section 1:	<b>Summary</b>
Section 2:	<b>Standard Tests</b>
Section 3:	<b>Slump Data</b>
Section 4:	<b>Reflow Data</b>

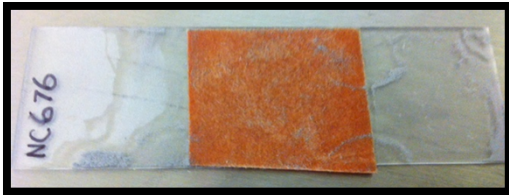
**Silver Chromate**

Pass

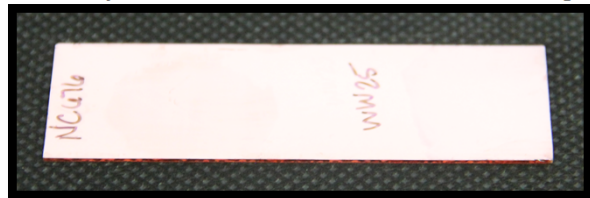
**Copper Mirror**

Pass (No evidence of mirror breakthrough)

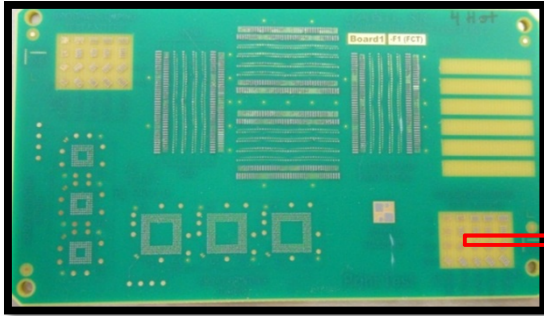
**Cold Slump**

Pad	Defect Count
0.10mm	0
0.15mm	0
0.20mm	0
0.225mm	0
0.25mm	0

**Cold Slump 0.06**  
**Passing Result**

25C slump fail  
limit (0.25mm)

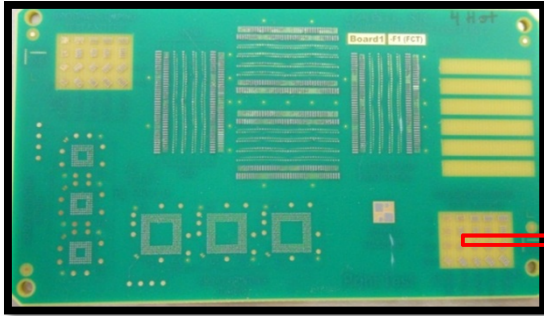
**Hot Slump**

Pad	Defect Count
0.10mm	0
0.15mm	0
0.20mm	0
0.225mm	0
0.25mm	0

Hot Slump 0.20  
**Passing Result**

150C slump fail  
limit (0.30mm)

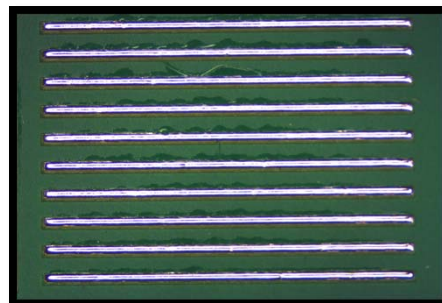
In each of the wetting/spread areas we identified the number of lines that had one or more bridge of the solder bricks. The maximum number of lines is 24. We then measure the most bricks that were bridged in one line. These results are shown below.

Board	Total Lines	Most on 1
1	24 out of 24	15 out of 15
2	24 out of 24	15 out of 15
3	24 out of 24	15 out of 15
4	24 out of 24	15 out of 15
Total	96 out of 96	60 out of 60

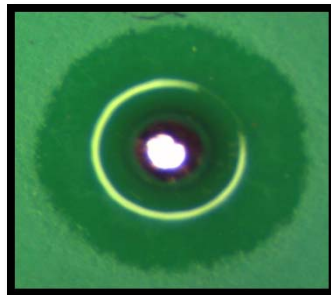
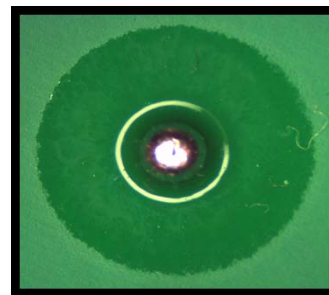
Measure the performance by volume of the solder paste to pullback on a pad. The start of the volume was at 500% with the maximum being 1250%. Any solder ball that was found not coalescing with the rest of the solder was failed.

Board	Pad Size
1	1225%
2	1225%
3	1225%
4	925%
Average	1150%

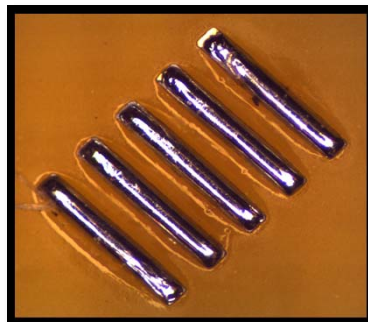
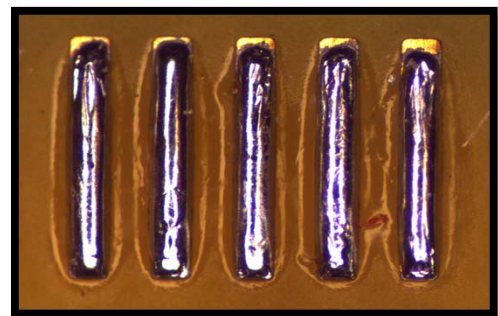
We measured the number of bridge occurrences and recorded in the tables below. We should note that the .1m m pads had minimal paste release which led to 0 bridges. Thus this pad offered no value in this study.

Board	Defect Count
1	0
2	4
3	0
4	5
Total	9
