Solder Paste Test Program (SPTP)

NL932 Solder Paste

Alloy: **SAC305 Type 3** Metal Loading: **88.5%** QC/Lot#: **23948** Mfg Date: **8/14/2012**

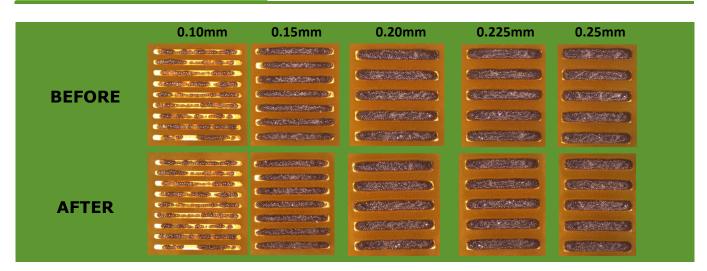
Cold Slump Test Board

Pad	Defect Count
0.10mm	0
0.15mm	0
0.20mm	0
0.225mm	0
0.25mm	0

Cold Slump 0.06 25C slump fail **Passing Result** limit (0.25mm)
