Problem Description:

SMT components QFN 16-pin and QFN 28-pin are having insufficient solder volume at reflow. 0402 components are experiencing tombstone and solder ball problems at reflow. The assembly is also experiencing cold solder joints and poor wetting at reflow.

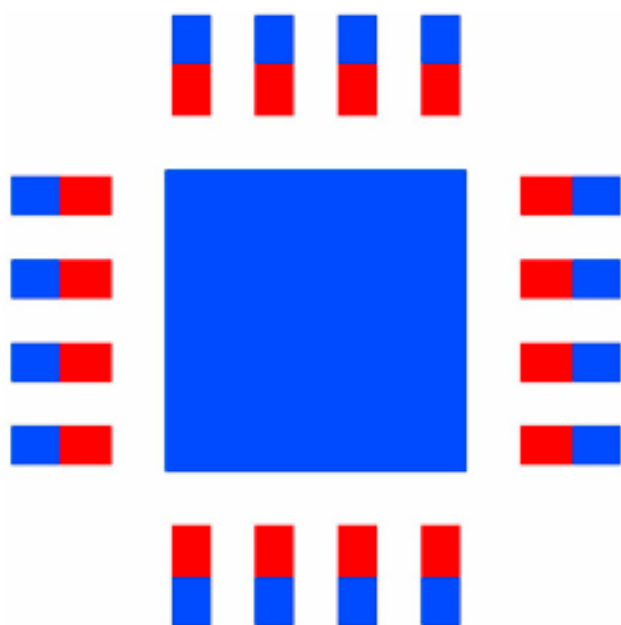
Allegro QFN 16-Pin
(red: termination, blue: SMT pad)

For leadless components, the terminal should cover 90%-100% of the SMT pad on the printed circuit board. On this assembly, the Allegro terminals cover 50% (terminal length is 0.0157" and SMT pad length is 0.0315") of the SMT pad and the Microchip terminals cover 47% (terminal length is 0.0157" and SMT pad length is 0.0335") of the SMT pad. The root cause of the insufficient solder volume is a result of too much surface area for the solder to wet to with enough left over to form an acceptable solder joint.

On leadless components, solder will uniformly wet to the surfaces of the terminal and SMT pad. When the terminal is 90%-100% of the SMT pad, solder is shared between the two surfaces. When the SMT pad is longer than the terminal, it creates surface area that is not shared between the two surfaces. Solder will be pulled from the joint during reflow to cover the additional surface area and the result is insufficient solder volume at the terminal.

To eliminate the insufficient solder problems with the QFN components, the volume of solder printed must be substantially increased, given the small leadless terminals and large, comparatively, SMT pads. Fine Line Stencil has developed proven formulas that calculate the required volume increase eliminate the insufficient solder volume problem without causing bridging. The recommended stencil aperture size is as follows:

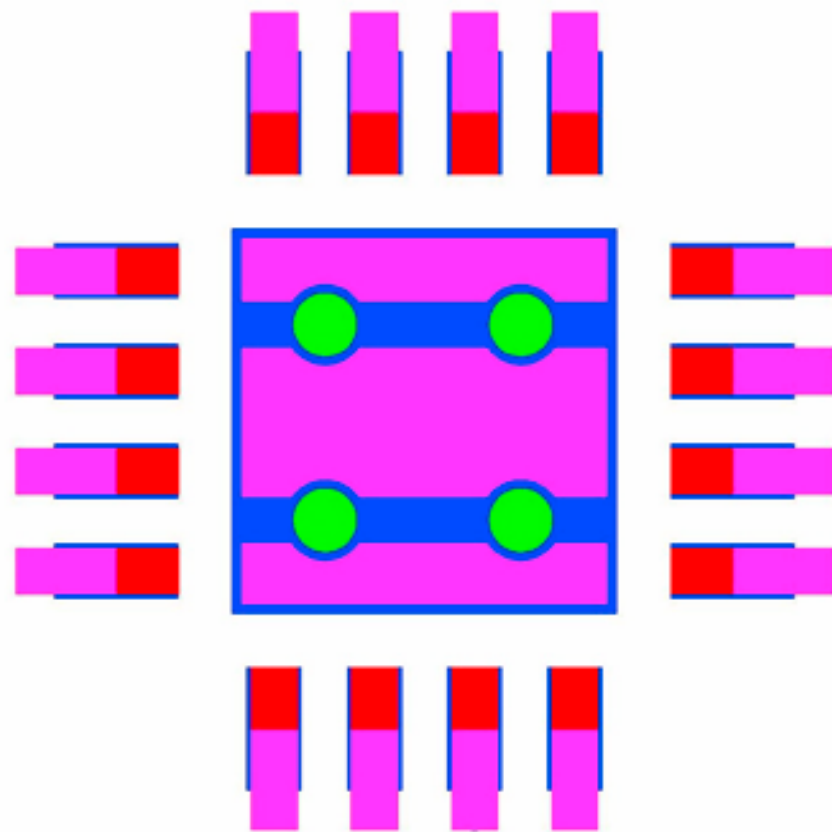
Allegro QFN 16-pin: 0.0118" x 0.0415" (25% volume increase for terminals and 40% volume reduction for thermal pad)

(blue = SMT pad, red = IC foot, magenta = recommended stencil aperture)

To minimize voids in the thermal pad, the four vias are not pasted. Applying solder paste around, but no directly over, the open vias minimizes the amount of flux and solder that gets lost to the via barrels. Voids in thermal pads with open vias are common not due to trapped gases, but insufficient solder volume. Not printing directly over the vias retains more of the solder volume for the joint between the PCB and component thermal pads.

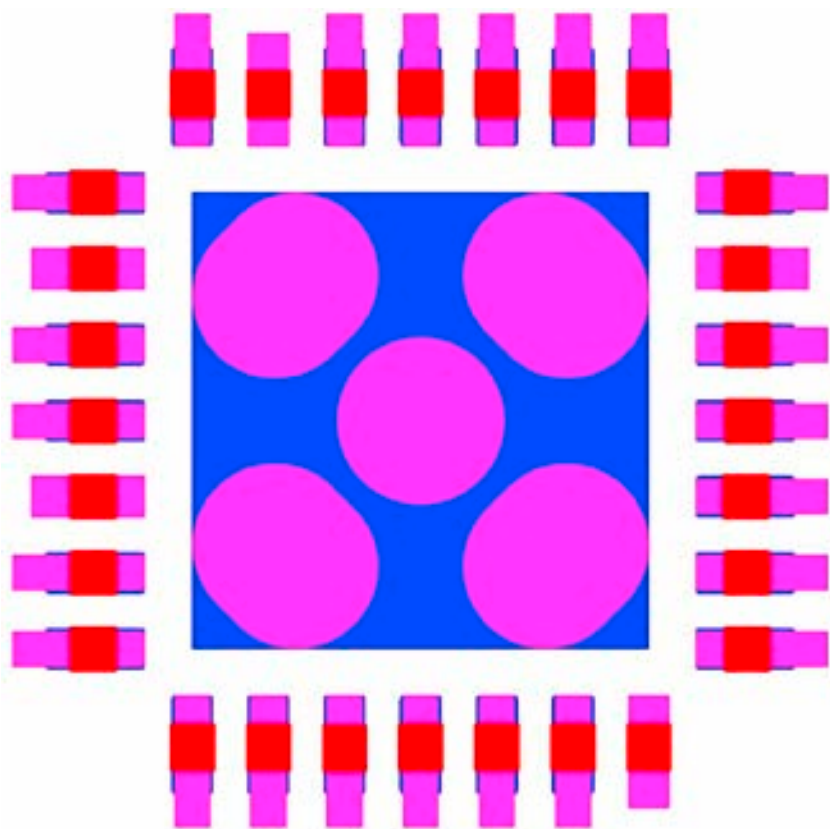
Microchip QFN 28-pin: 0.0118” x 0.0445” (26.5% volume increase for terminals and 40% volume reduction for thermal pad)
(blue = SMT pad, red = IC foot, magenta = recommended stencil aperture)

Some of the stencil apertures on the Microchip QFN are shorter and wider. This is due to the 0.0445” long aperture printing onto open vias. Solder volume will be lost to the open vias. The stencil apertures in several locations were shortened and widened to keep the same volume, but avoid the vias.

There are no open vias in this QFN. The “5-dot” aperture minimizes voids and skewing of the QFN.
